Sixty years of landscape change within an Arctic Oilfield, Prudhoe Bay, Alaska

Martha Raynolds, Donald A. Walker, Gary
P. Kofinas, Ken J. Ambrosius

Land Cover Land Use Mapping Workshop
Rovaniemi, Finland
20 May 2012

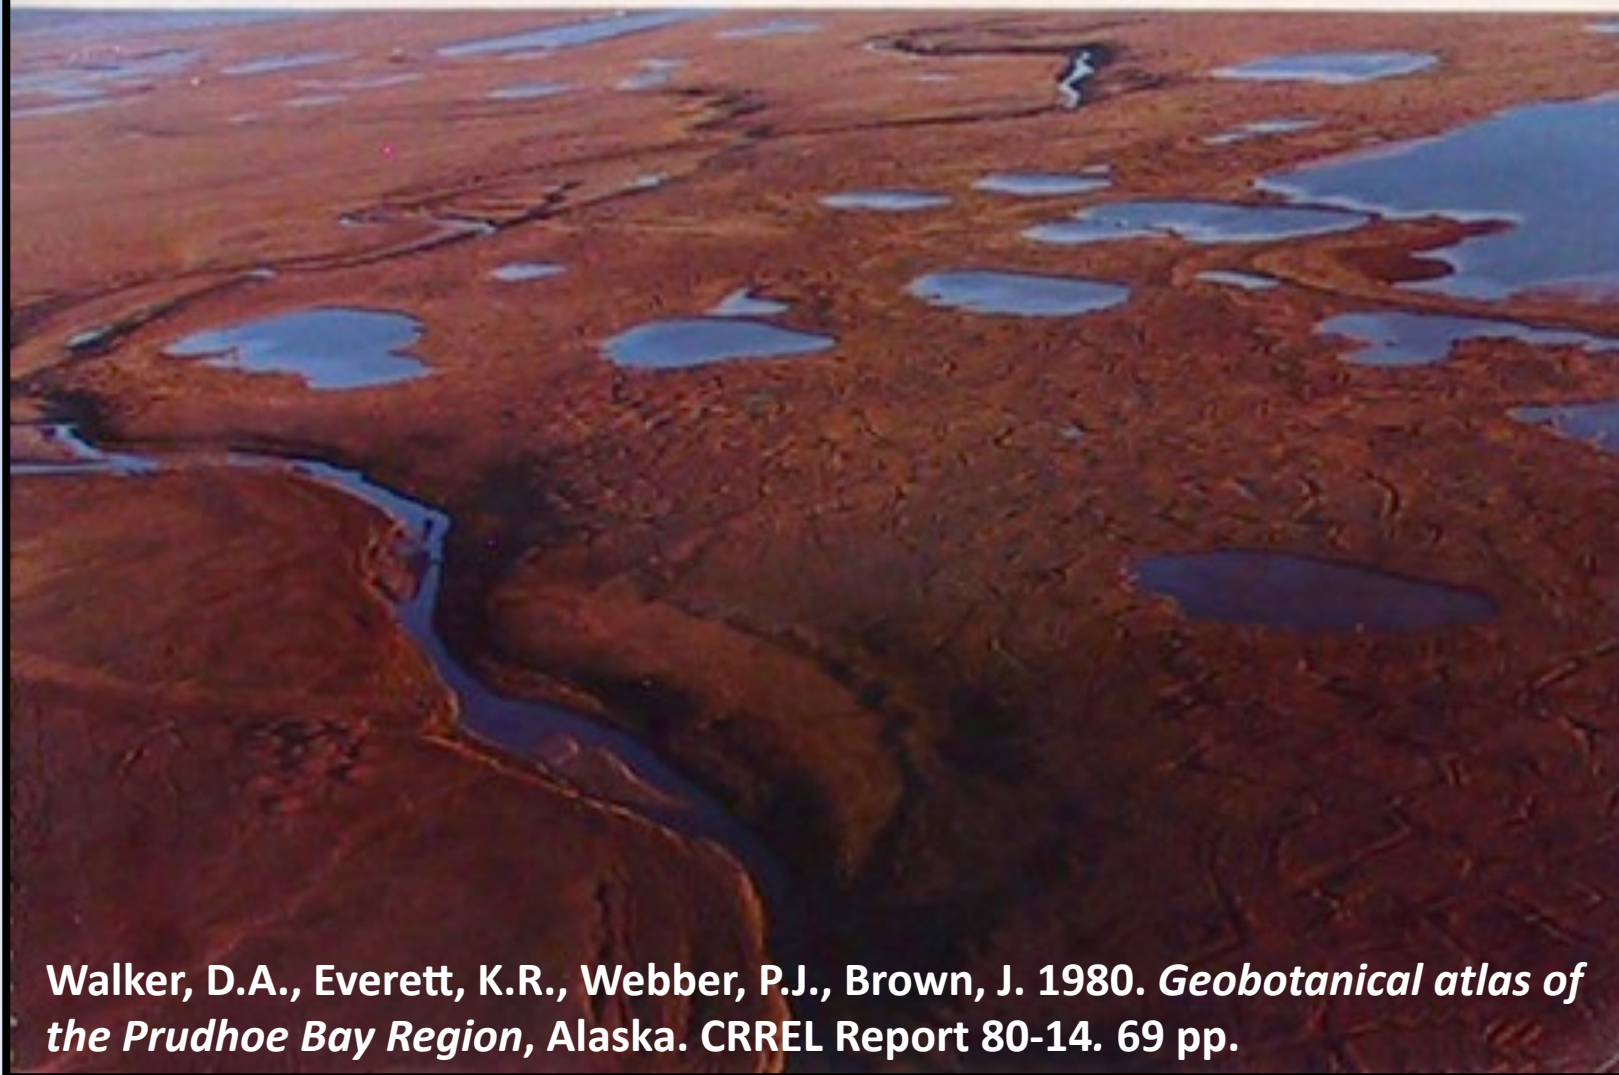
Geobotanical Atlas of the Prudhoe Bay Region, Alaska

Walker, D.A., Everett, K.R., Webber, P.J., Brown, J. 1980. *Geobotanical atlas of the Prudhoe Bay Region, Alaska*. CRREL Report 80-14. 69 pp.

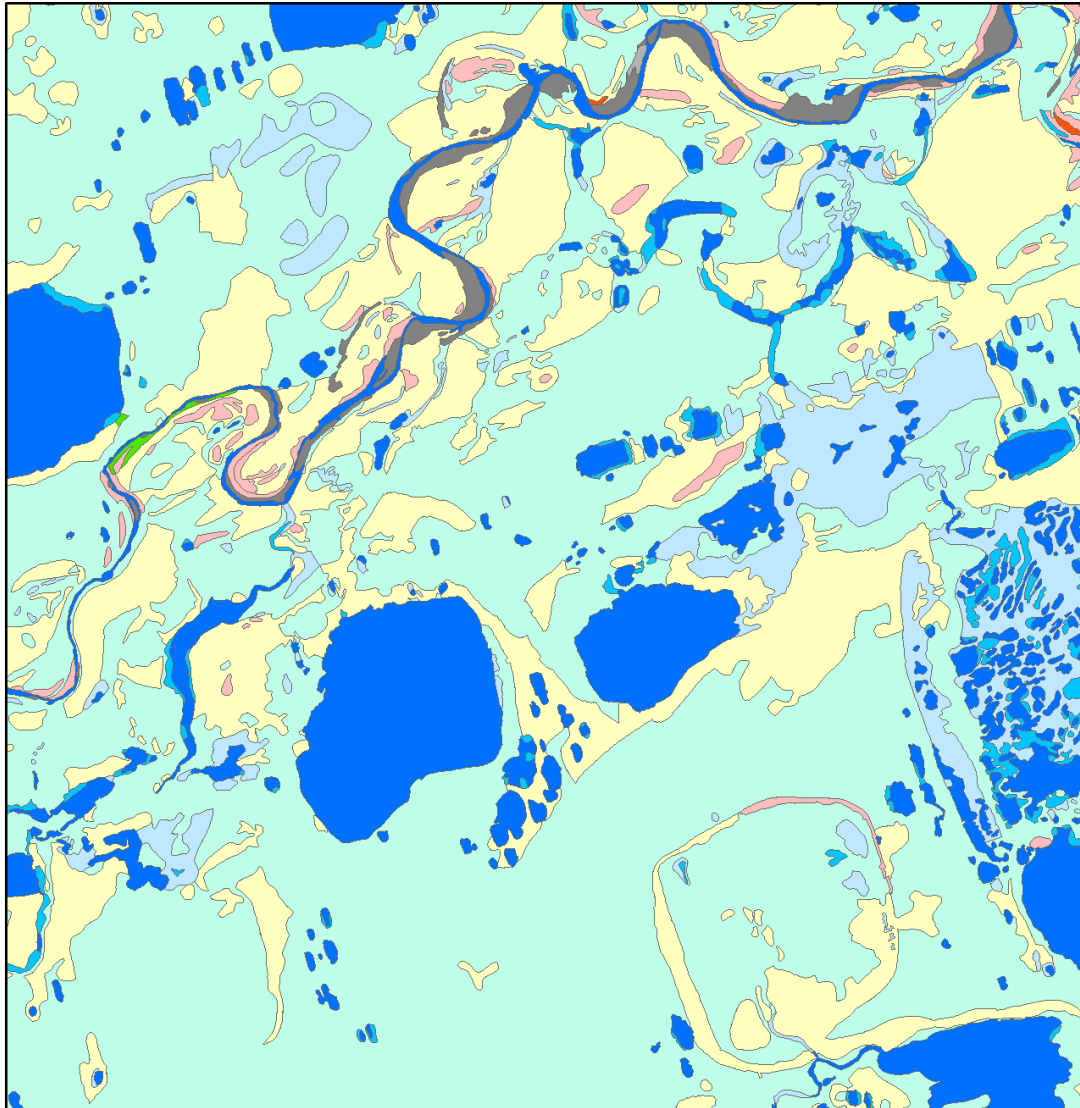
Primary Vegetation

Mapping of geobotanical attributes before development

- Water
- Aquatic grass marsh
- Aquatic sedge marsh
- Wet sedge, moss tundra
- Moist nontussock-sedge, dwarf-shrub moss tundra
- Moist low shrubland
- Dry prostrate dwarf-shrub, lichen tundra
- Dry prostrate dwarf-shrub, forb, grass tundra
- Barren

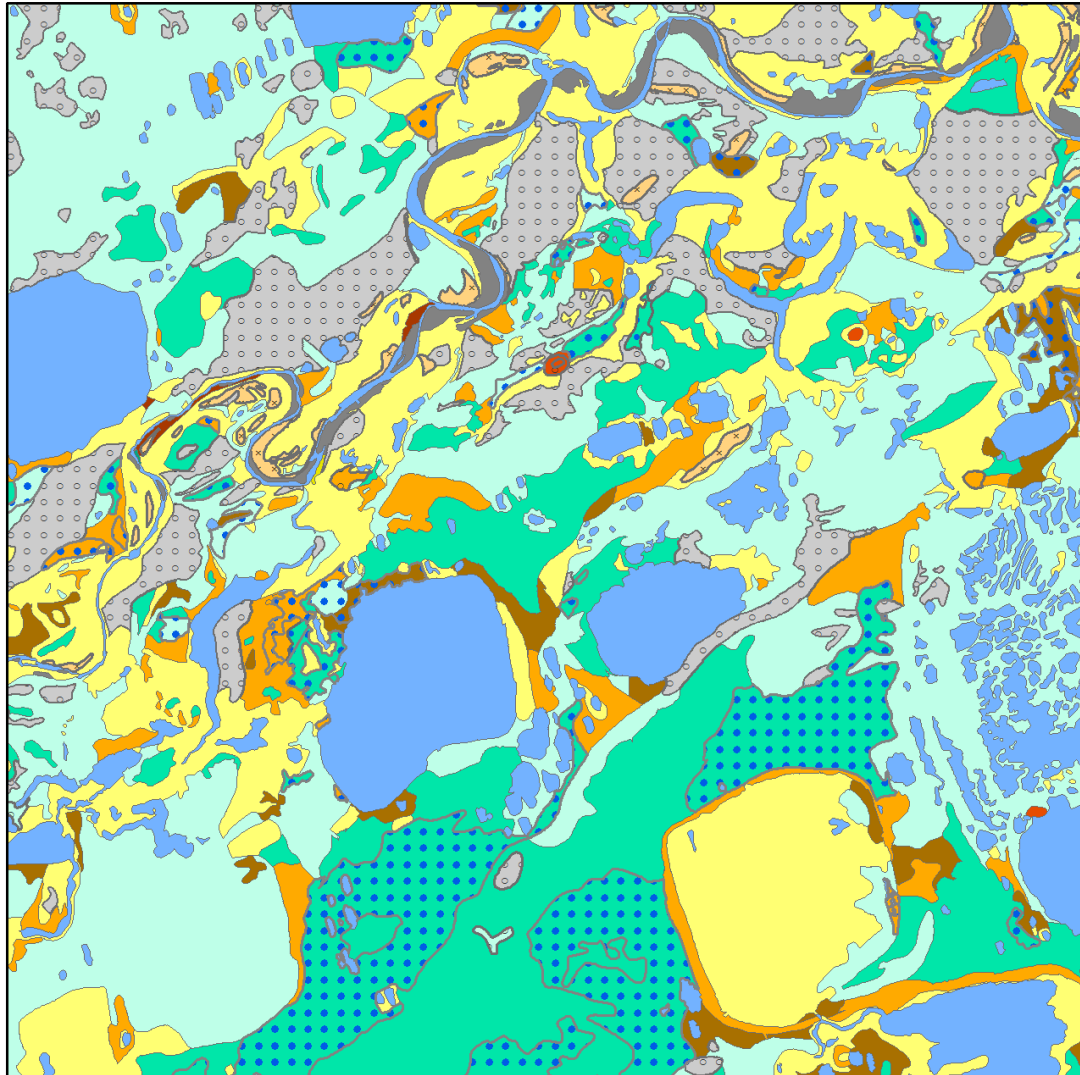
Surface Form

Mapping of geobotanical attributes before development

- Low-centered polygons relief > 0.5 m
- Low-centered polygons relief < 0.5 m
- Low-centered polygons with thermokarst pits
- Strangmoor
- Mixed high- and low-centered polygons
- High-centered polygons
- Pingo
- Non-patterned ground
- Reticulate patterned ground
- Frost scars
- Floodplain alluvium
- Water

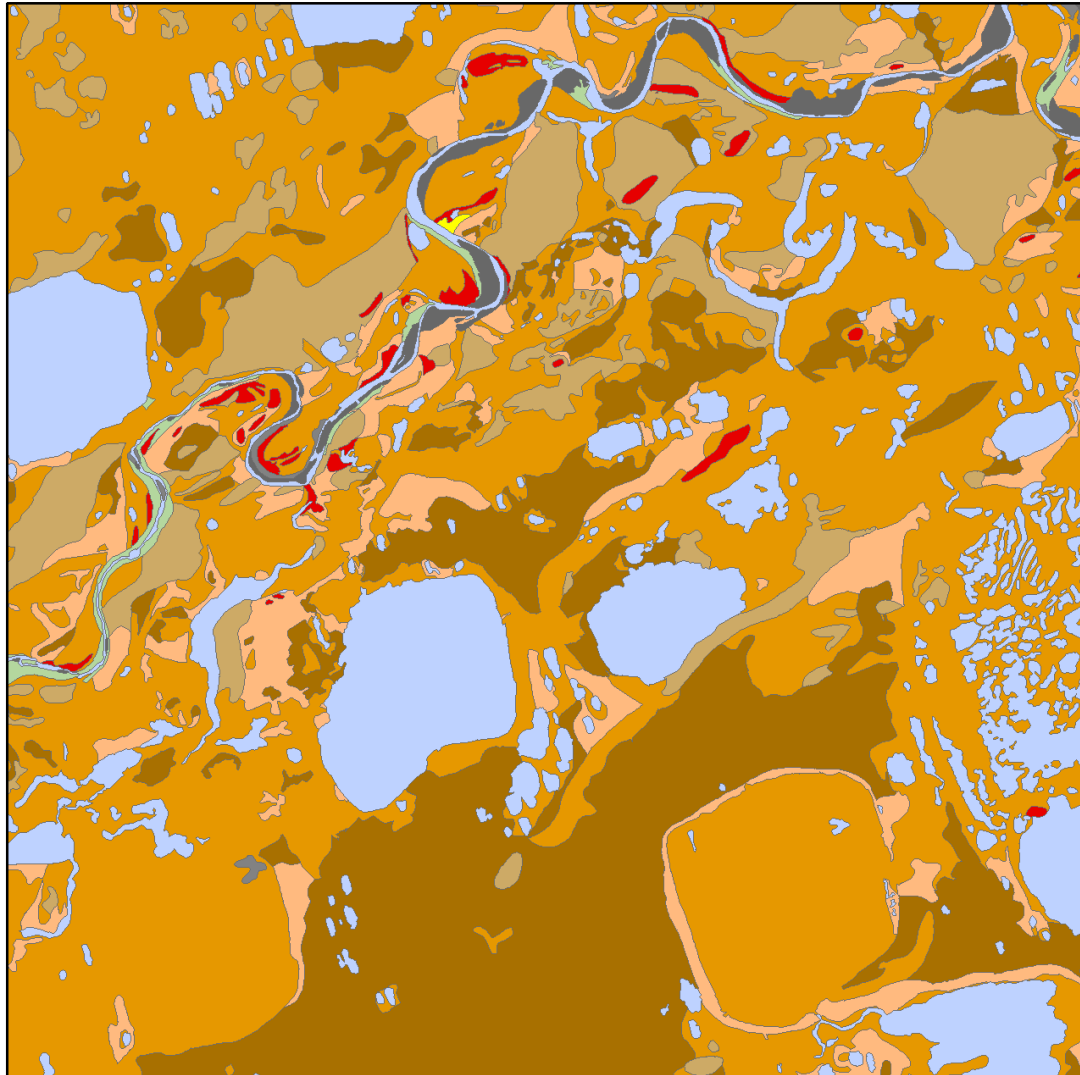
Soil

Mapping of geobotanical attributes before development

- Pergelic Cryoborolls
- Pergelic Cryaquolls or Cryosaprists
- Complex of a) Pergelic Cryohemists or Cryofibrists, b) Histic Pergelic Cryaquepts, c) Pergelic Cryaquepts
- Association of a) Pergelic Cryohemists or Cryofibrists or Histic Pergelic Cryaquepts, b) Pergelic Cryosaprists or Cryaquolls
- Association of a) Pergelic Cryaquolls or Cryosaprists, b) Pergelic Cryaquepts (frost boils)
- Pergelic Cryorthents
- Pergelic Cryopsammments
- Pergelic Cryaquepts
- Floodplain Alluvium
- Water

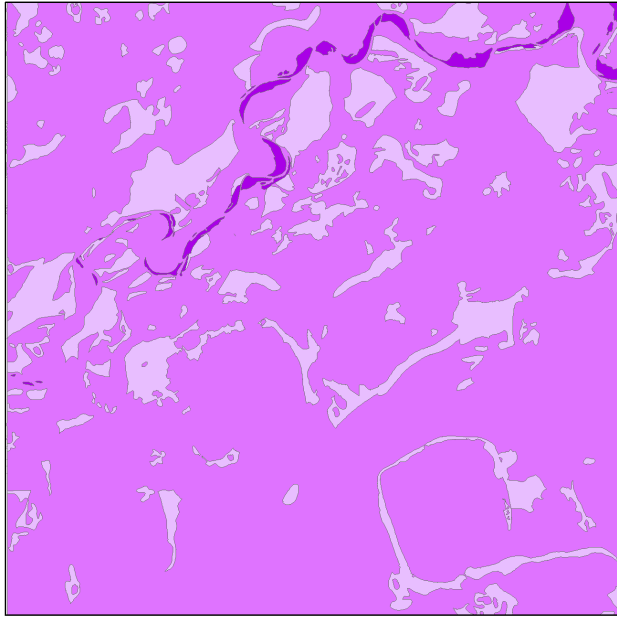
Snow Depth

- Less than 30 cm
- 30 to 60 cm
- Greater than 60 cm

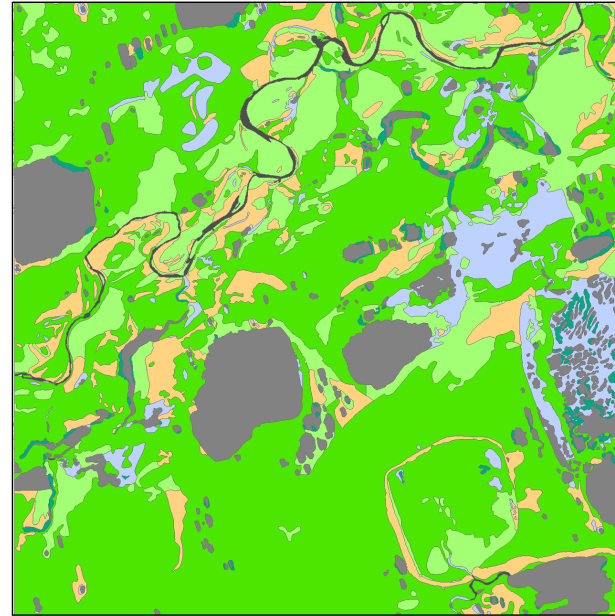
Water and Wet Terrain

- Flowing water (streams and rivers)
- Lakes and ponds with no vegetation; > 50 cm deep
- Lakes and ponds with aquatic grass; water 30 to 100 cm deep
- Lakes and ponds with sedges; water 15 to 30 cm deep
- Perennial standing water < 15 cm deep; often with polygonal or strangmoor landform features
- Transitional wet terrain; water table at or above surface early in summer, below surface by mid-summer
- Upland areas; water table absent or coincident with permafrost table all summer

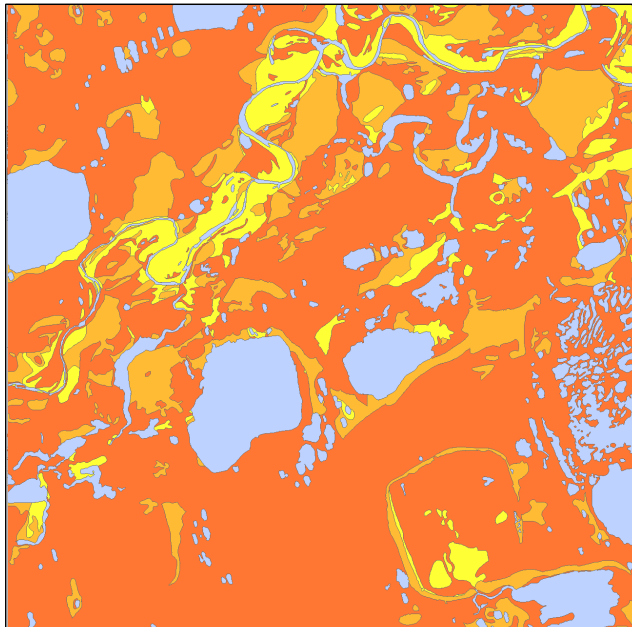
Off-Road Vehicle Sensitivity

- High
- Moderate
- Low
- Water

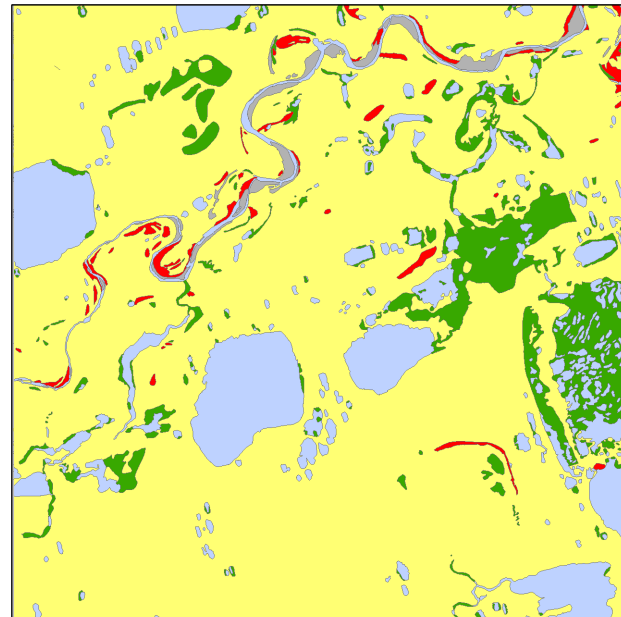
Oil Spill Recovery Potential

- Good to excellent
- Moderate
- Poor
- River gravel
- Water

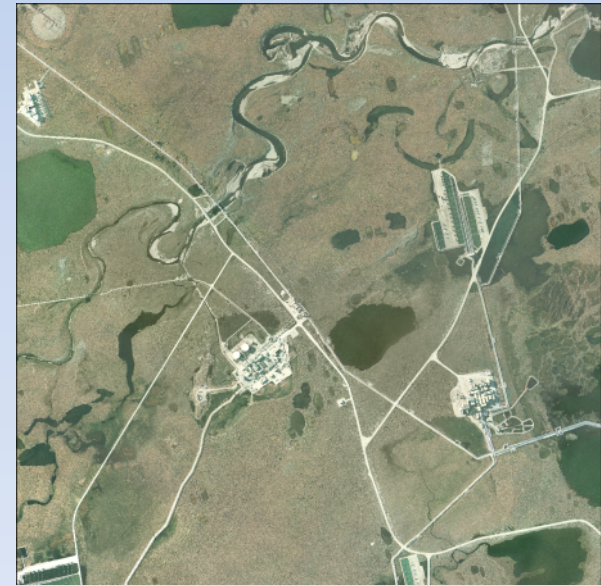
2010 true color

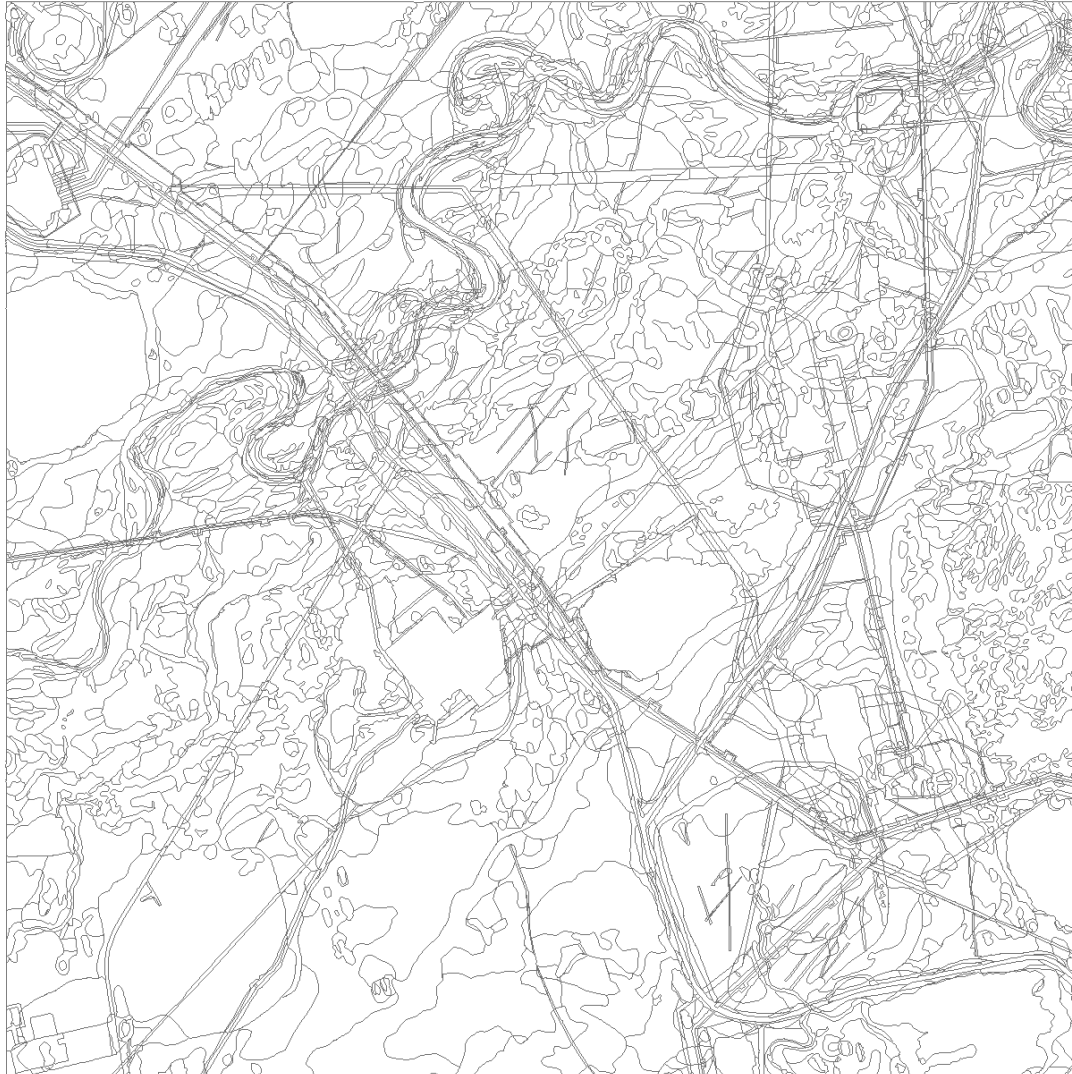
GIS Attributes

Digitized polygons of pre-development geobotanical features and subsequent changes

- Vegetation
- Soils
- Landform
- Water
- Human disturbance
(for each year)
- Natural disturbance
(for each year)

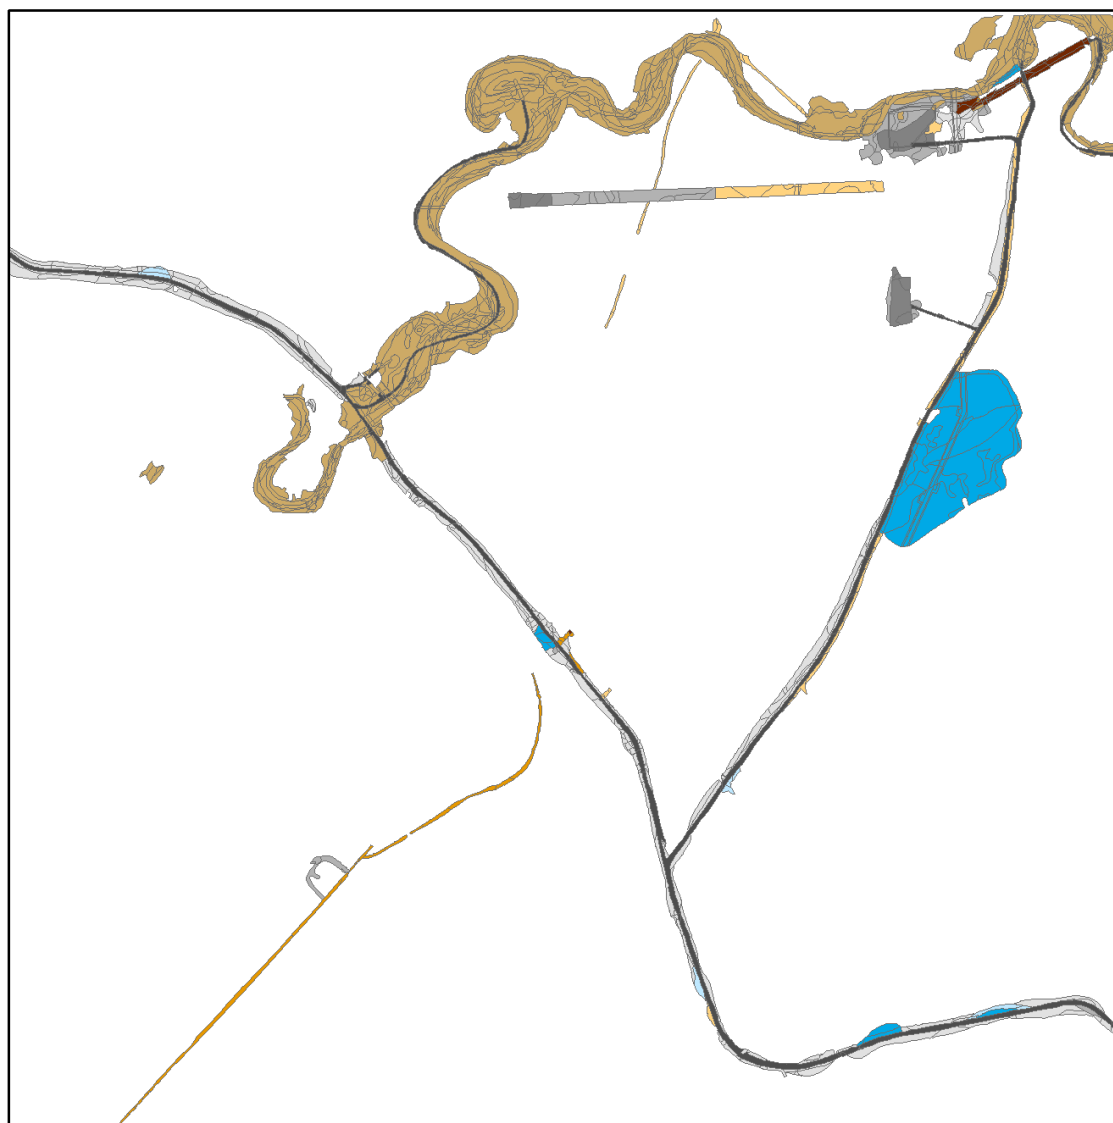
Industrial Disturbance 1970

- Gravel road
- Peat road
- Gravel pad
- Continuous flooding
- Discontinuous flooding
- Deep tracks
- Shallow tracks
- >75% gravel debris
- < 75% gravel debris
- Excavation
- Barren tundra due to flooding

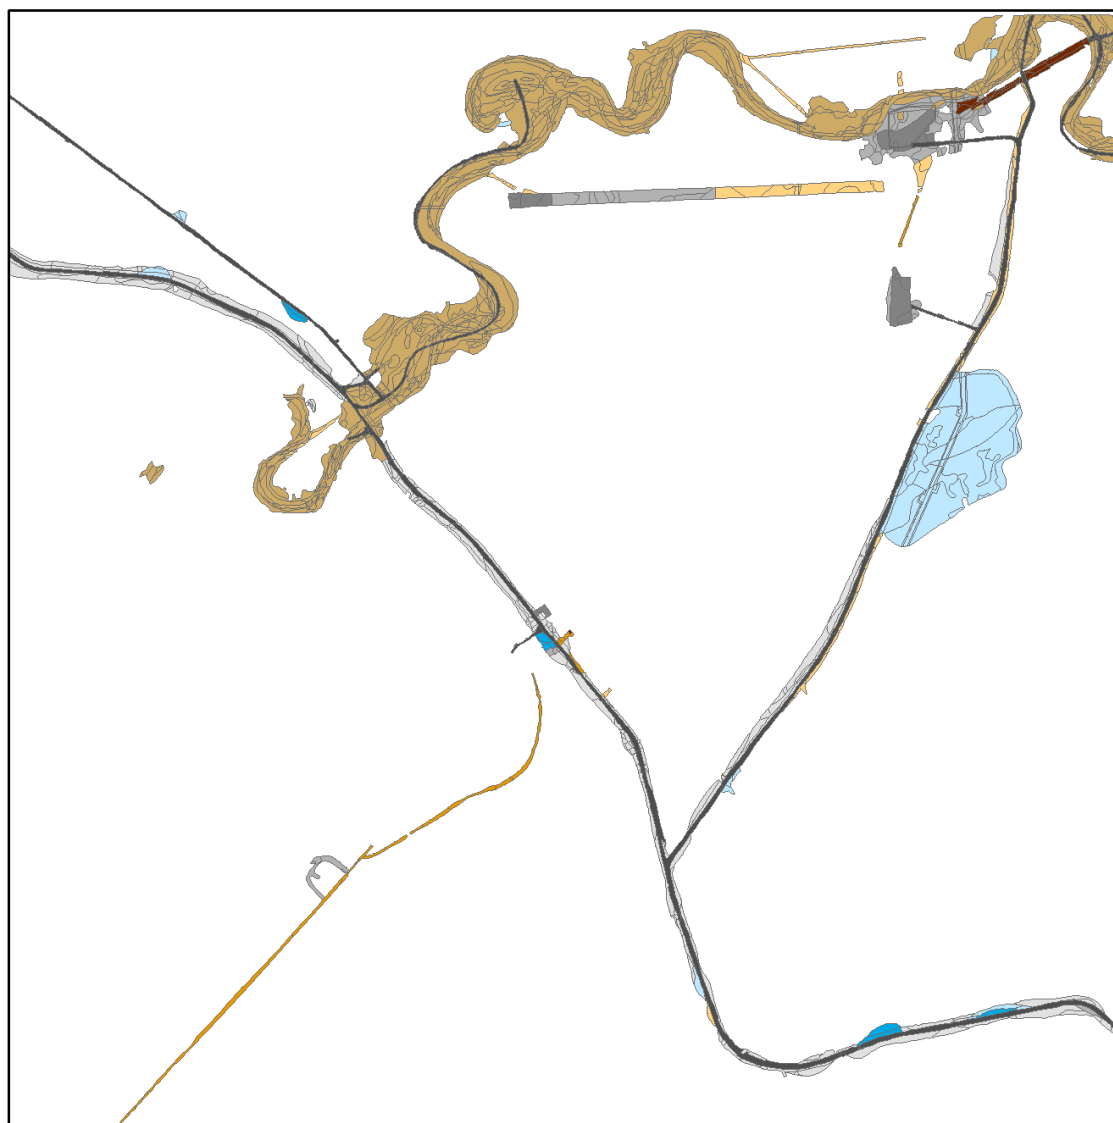
Industrial Disturbance 1972

- Gravel road
- Peat road
- Gravel pad
- Continuous flooding
- Discontinuous flooding
- Deep tracks
- Shallow tracks
- >75% gravel debris
- < 75% gravel debris
- Excavation
- Barren tundra due to flooding

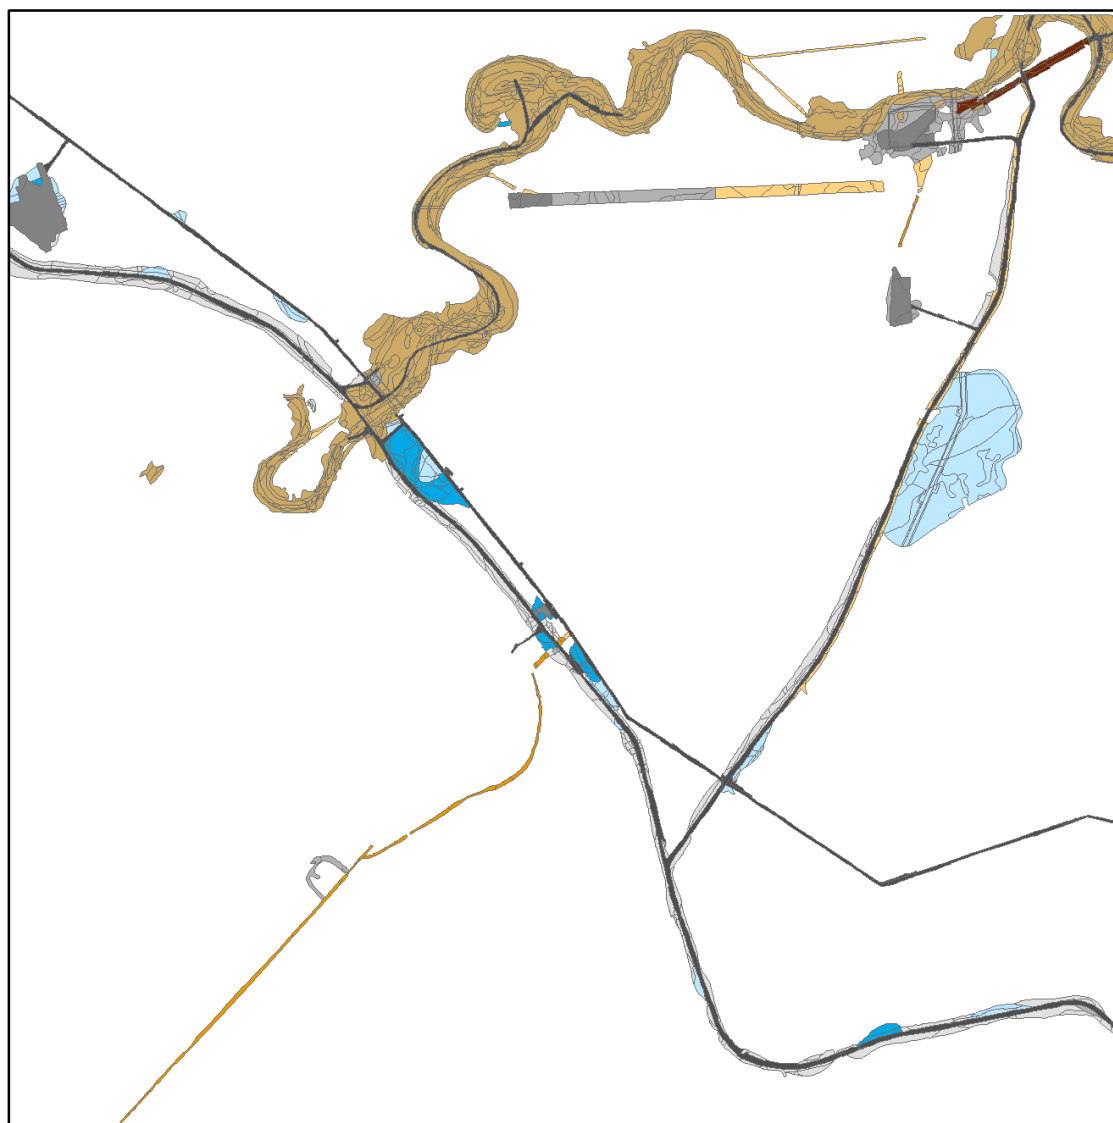
Industrial Disturbance 1973

- Gravel road
- Peat road
- Gravel pad
- Continuous flooding
- Discontinuous flooding
- Deep tracks
- Shallow tracks
- >75% gravel debris
- < 75% gravel debris
- Excavation
- Barren tundra due to flooding

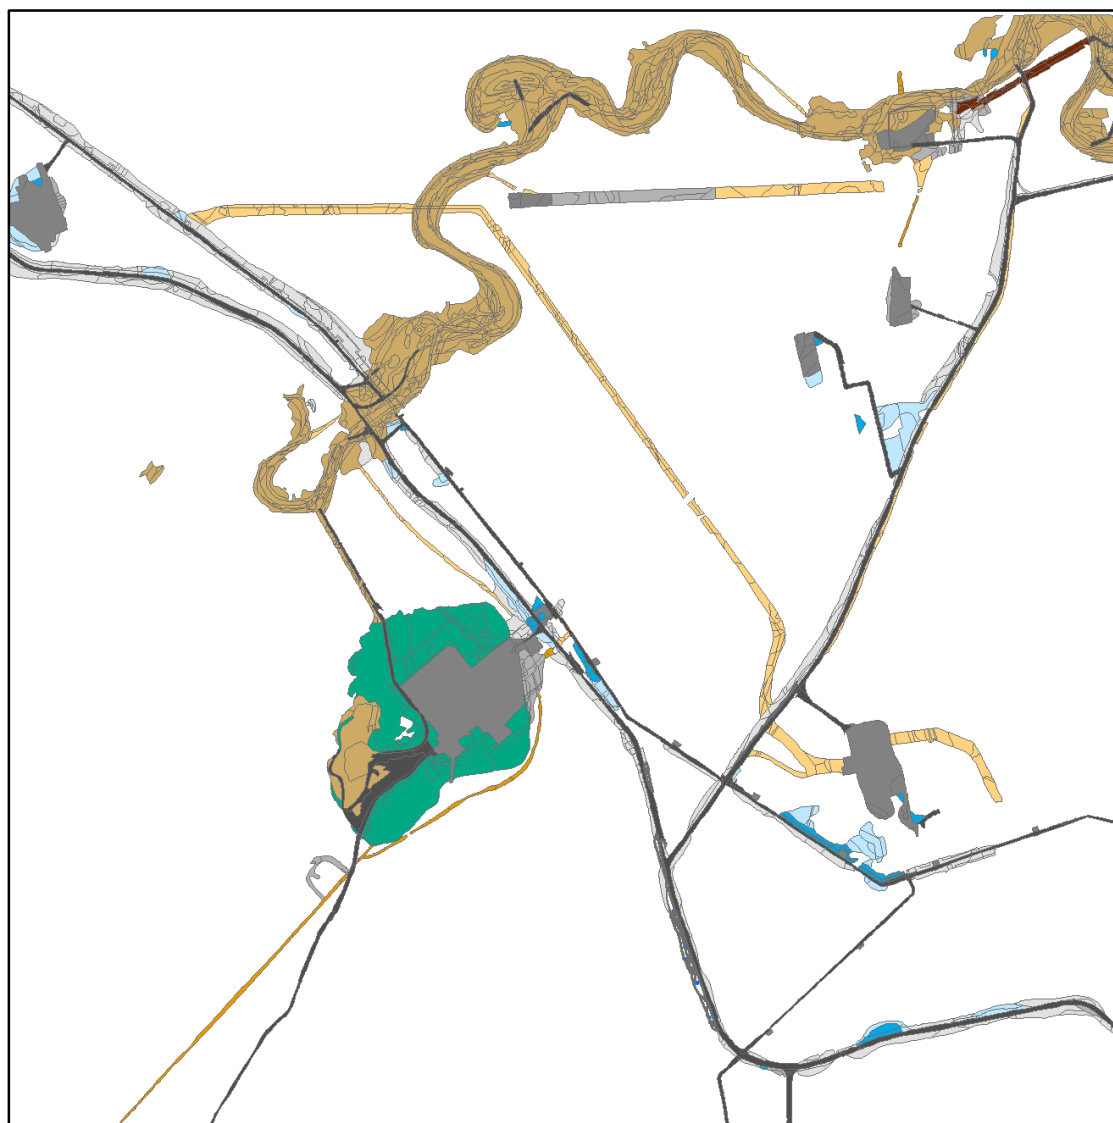
Industrial Disturbance 1977

- Gravel road
- Peat road
- Gravel pad
- Continuous flooding
- Discontinuous flooding
- Deep tracks
- Shallow tracks
- >75% gravel debris
- < 75% gravel debris
- Excavation
- Barren tundra due to flooding

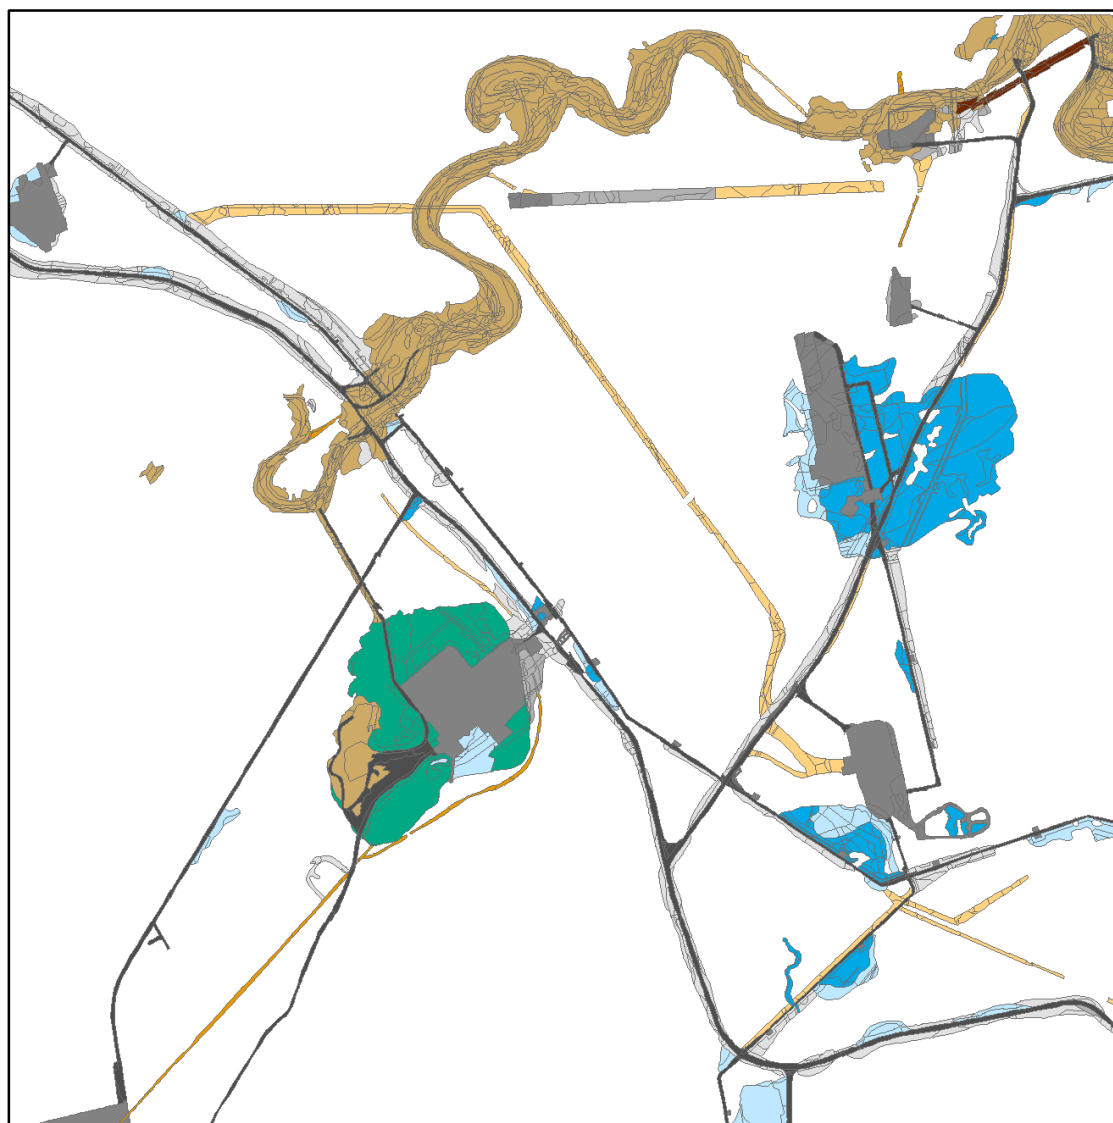
Industrial Disturbance 1979

- Gravel road
- Peat road
- Gravel pad
- Continuous flooding
- Discontinuous flooding
- Deep tracks
- Shallow tracks
- >75% gravel debris
- < 75% gravel debris
- Excavation
- Barren tundra due to flooding

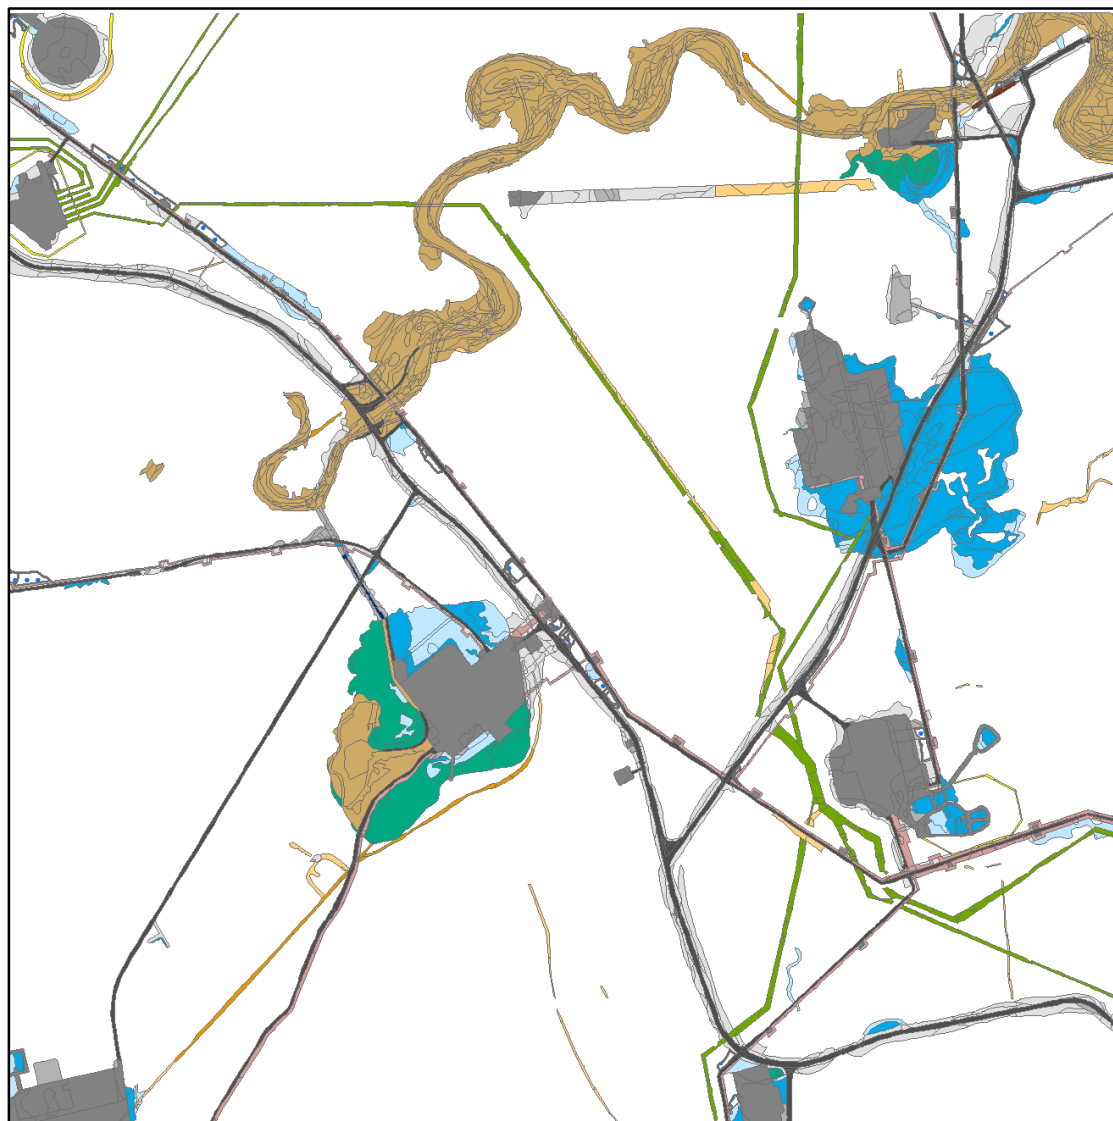
Industrial Disturbance 1990

- Gravel road
- Peat road
- Gravel pad
- Continuous flooding
- Discontinuous flooding
- Increase thermokarst pits
- Deep tracks
- Shallow tracks
- >75% gravel debris
- < 75% gravel debris
- Excavation
- Barren tundra due to flooding
- Pipeline
- Powerline

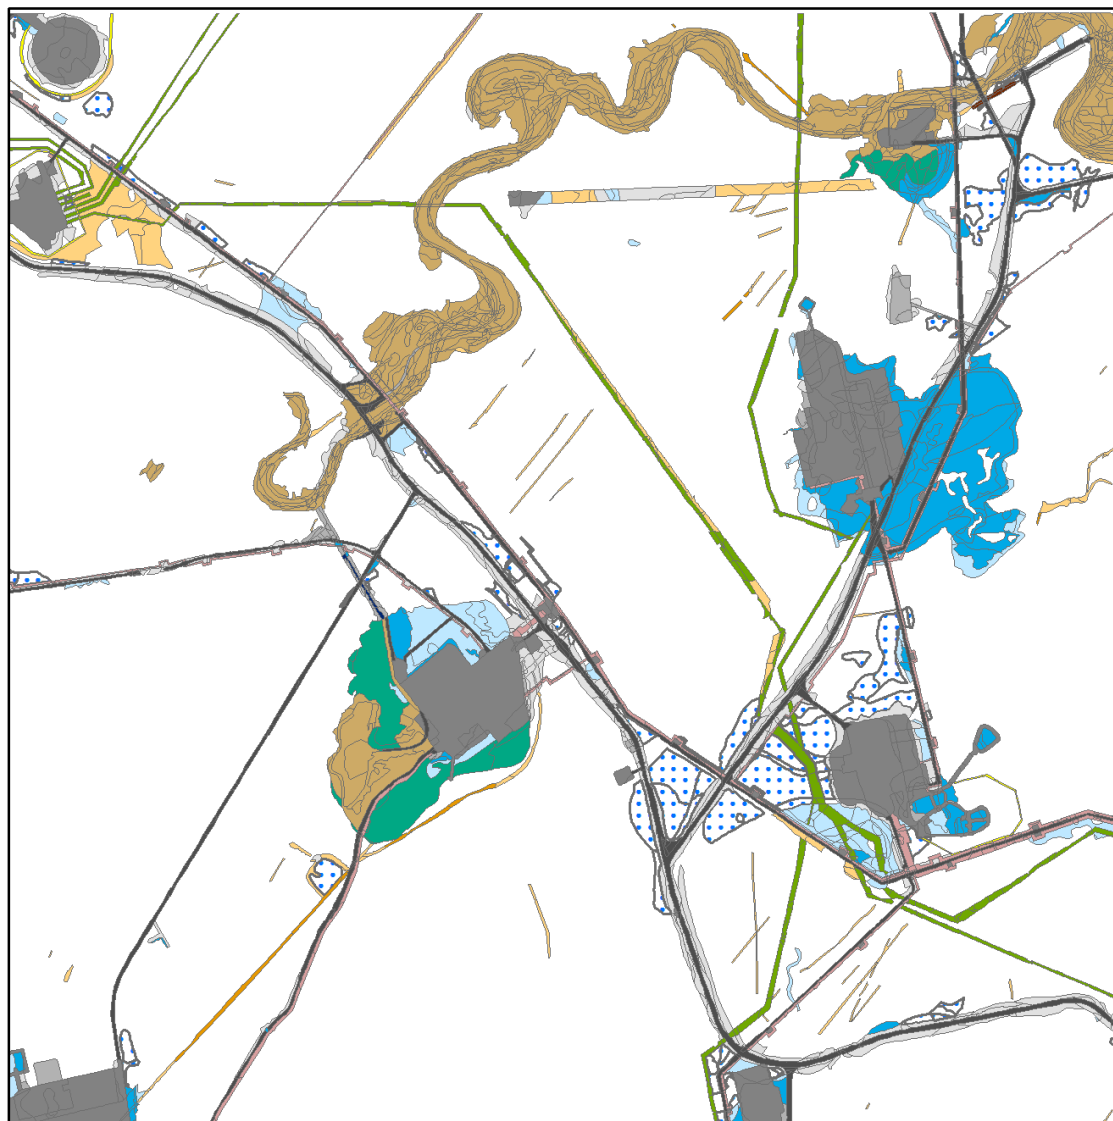
Industrial Disturbance 2001

- Gravel road
- Peat road
- Gravel pad
- Continuous flooding
- Discontinuous flooding
- Increase thermokarst pits
- Deep tracks
- Shallow tracks
- >75% gravel debris
- < 75% gravel debris
- Excavation
- Barren tundra due to flooding
- Pipeline
- Powerline

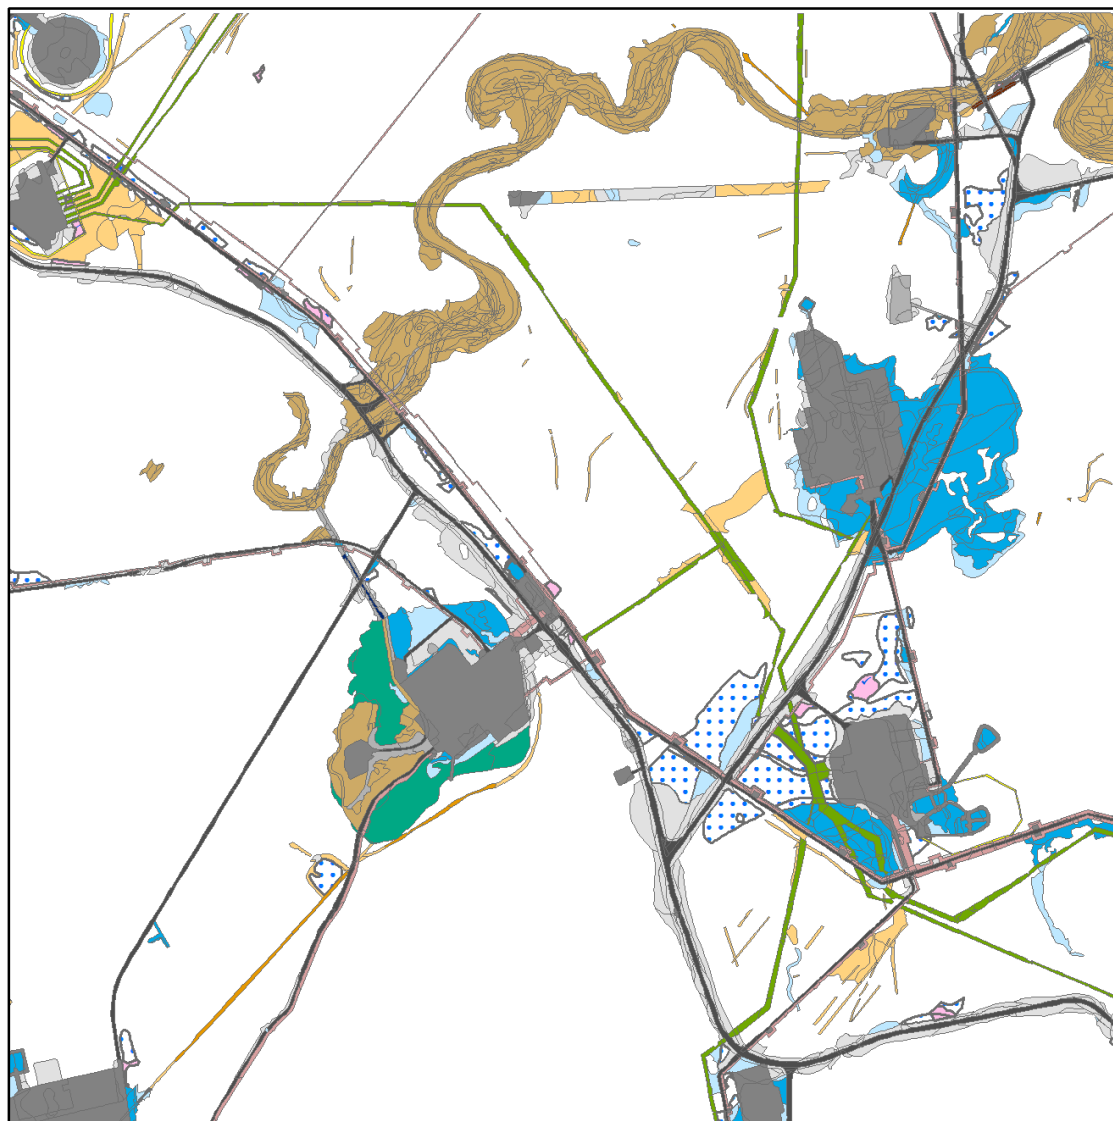
Industrial disturbance 2010

- Gravel road
- Peat road
- Gravel pad
- Continuous flooding
- Discontinuous flooding
- Increase thermokarst pits
- Deep tracks
- Shallow tracks
- >75% gravel debris
- < 75% gravel debris
- Excavation
- Drained lake bed
- Pipeline
- Powerline
- Fence
- Canal
- Ice-wedge degradation
- Ice-wedge loss

Disturbance due to industrial development

A total of 689 ha were affected by industrial development by 2010, 33% of the study area.

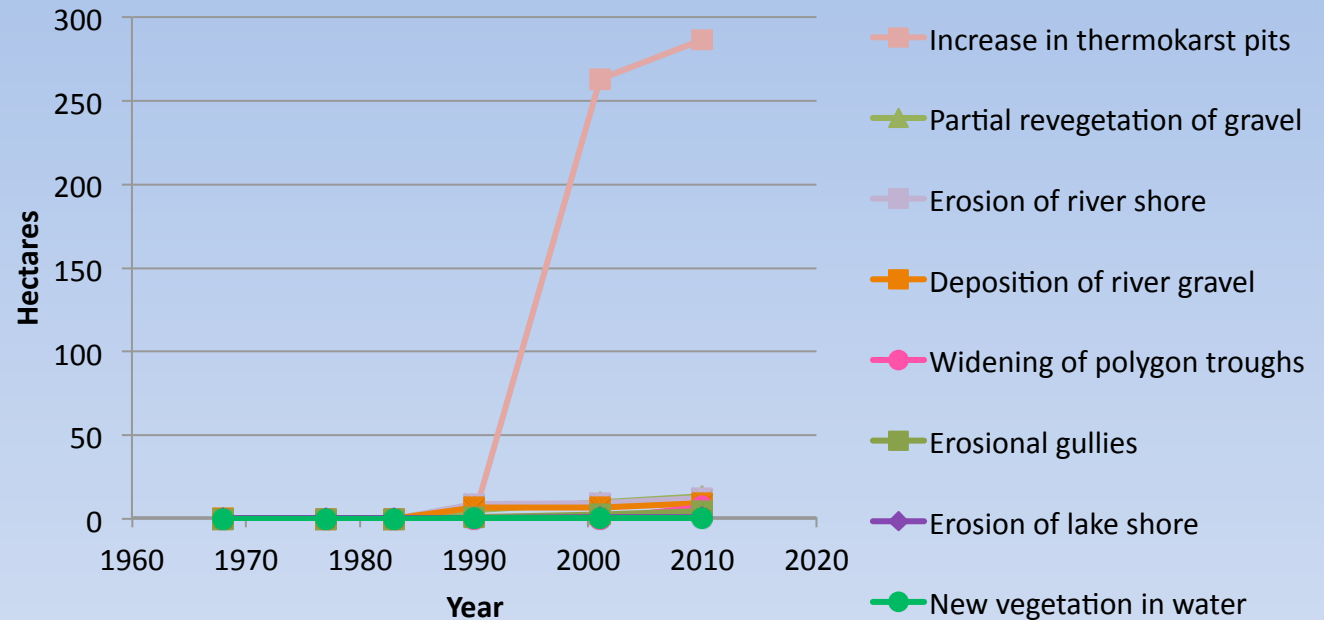
Area of change from causes other than oilfield development

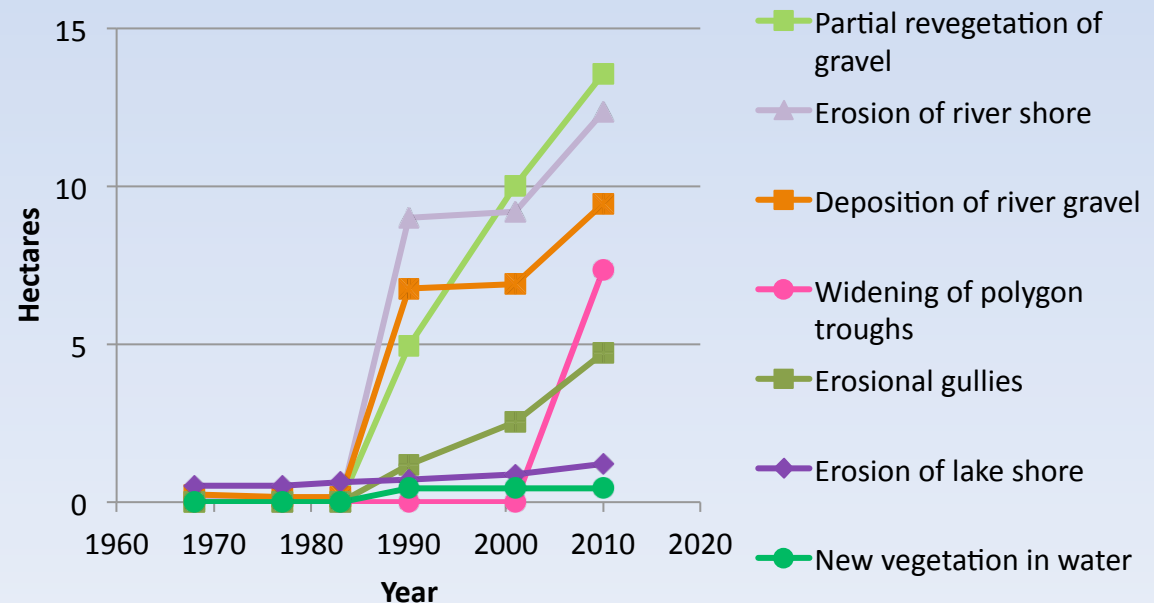
Area of change, excluding thawing of ice-wedges

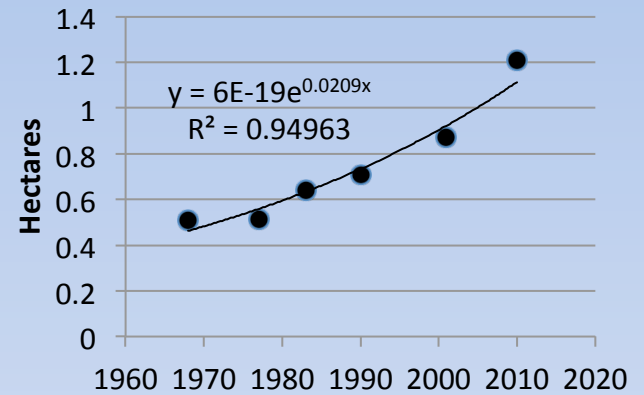
Total lake shore erosion for Map 32

Erosion of Lake Shore 1949-2010

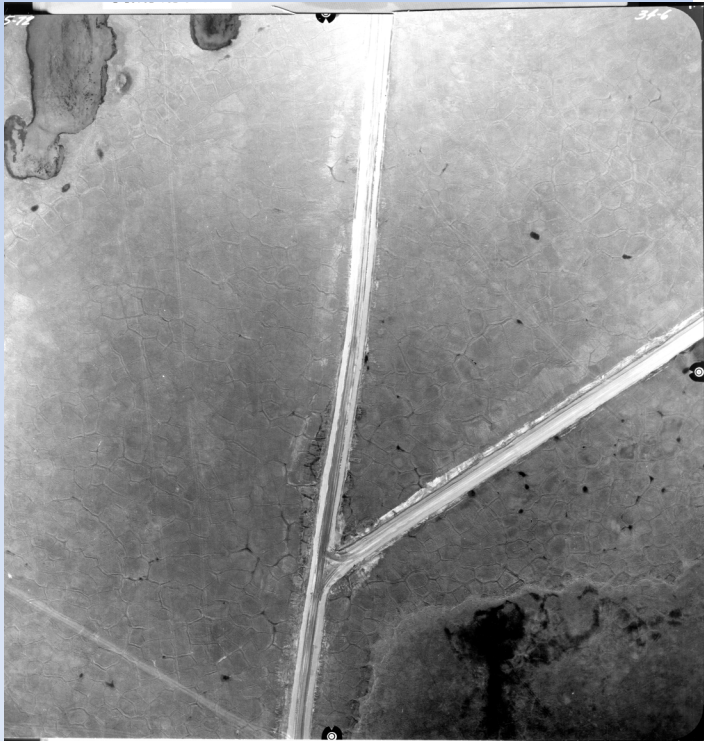
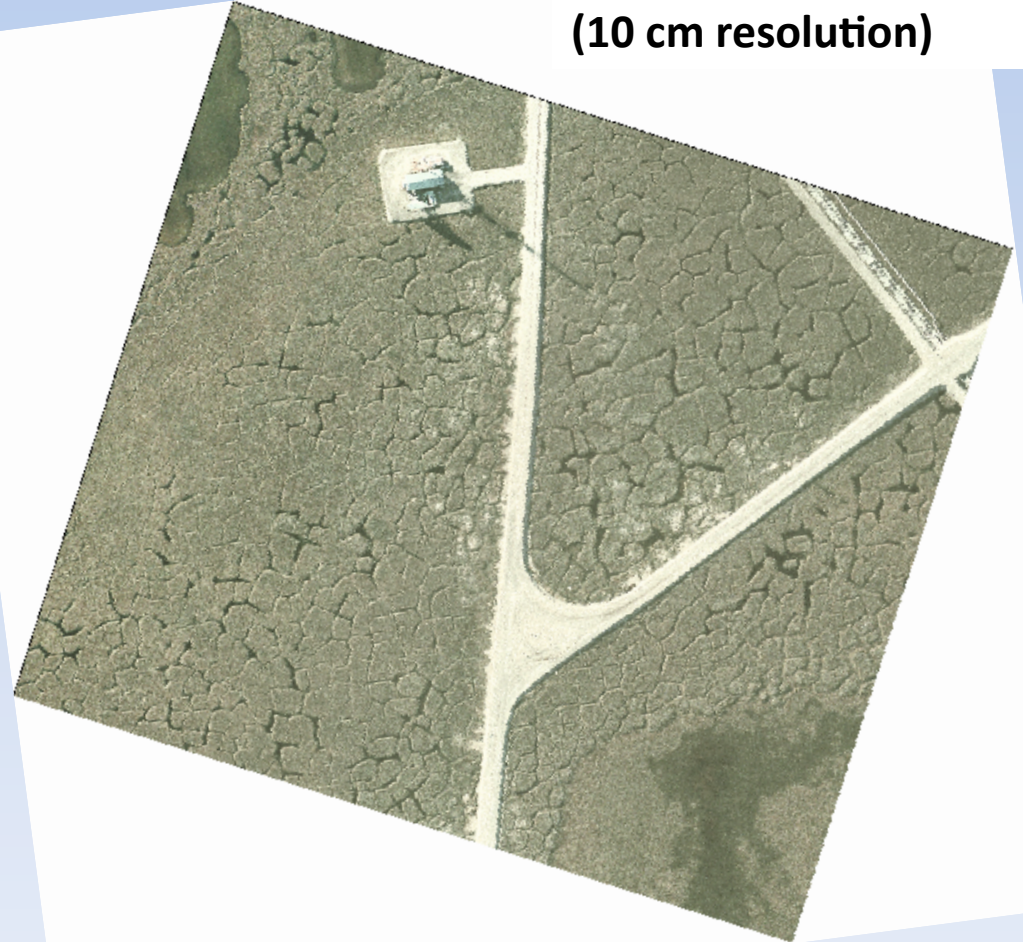
Permafrost degradation

1972 black & white 1:3,00

**2010 true color digital
(10 cm resolution)**
